# A "HORNY" Problem

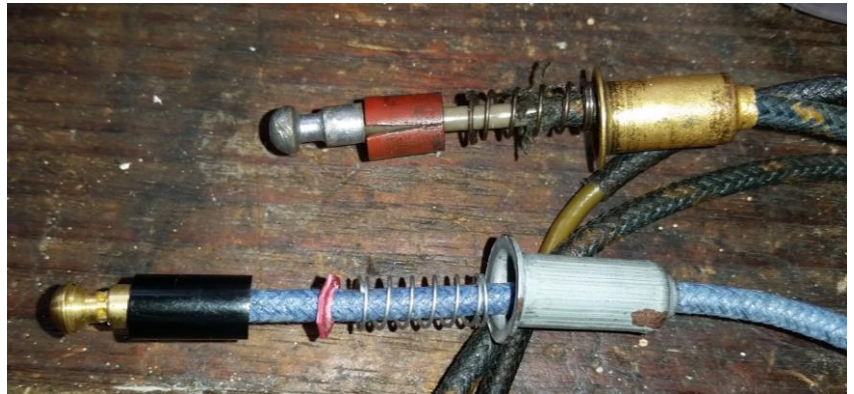
On closer inspection I found that the old wire, on the steering wheel end, could be the culprit. The wire has an end connector which is covered by a plastic shroud which the spring rests against which again fits into the ferrule which locates this end centrally in the steering column. I found that the plastic shroud was split down the side allowing it to slip further up and over the end connector.

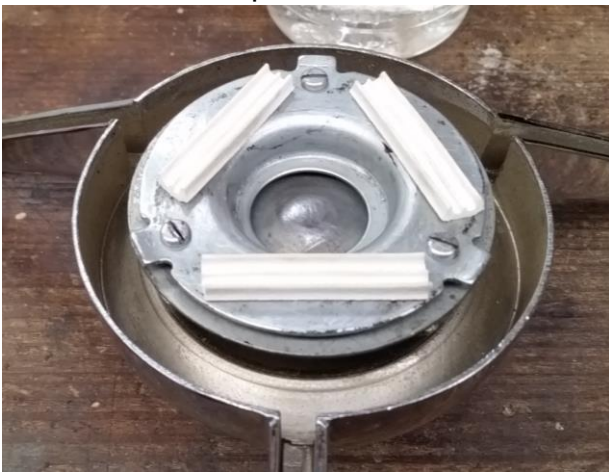
This then allowed the end connector to protrude below the shroud which the spring could contact. The spring then contacted the locating ferrule which sat in the steering column completing the electrical circuit which caused the HORN to start blaring.

A new cable was purchased from the Rubber Connection, for the sum of \$28.50, and was promptly installed into the steering column on my return home. Whilst I was at it I replaced the perished rubber rattle blocks attached to the inner horn rim assembly, which when the horn rim was refitted worked great. I then connected the horn wire to the horn loom connector just in front of the fire wall. The terminal block wire was
